Introduction

Stantec Consulting Ltd. (the consultant) in collaboration with Federated Co-operatives Limited (FCL) (the proponent) developed an innovative insitu remediation research strategy to remediate PHC impacts at a residential property. This research was completed as part of FCL's commitment to the Sustainable Insitu Remediation Co-operative Alliance (SIRCA).

Remediation Concept

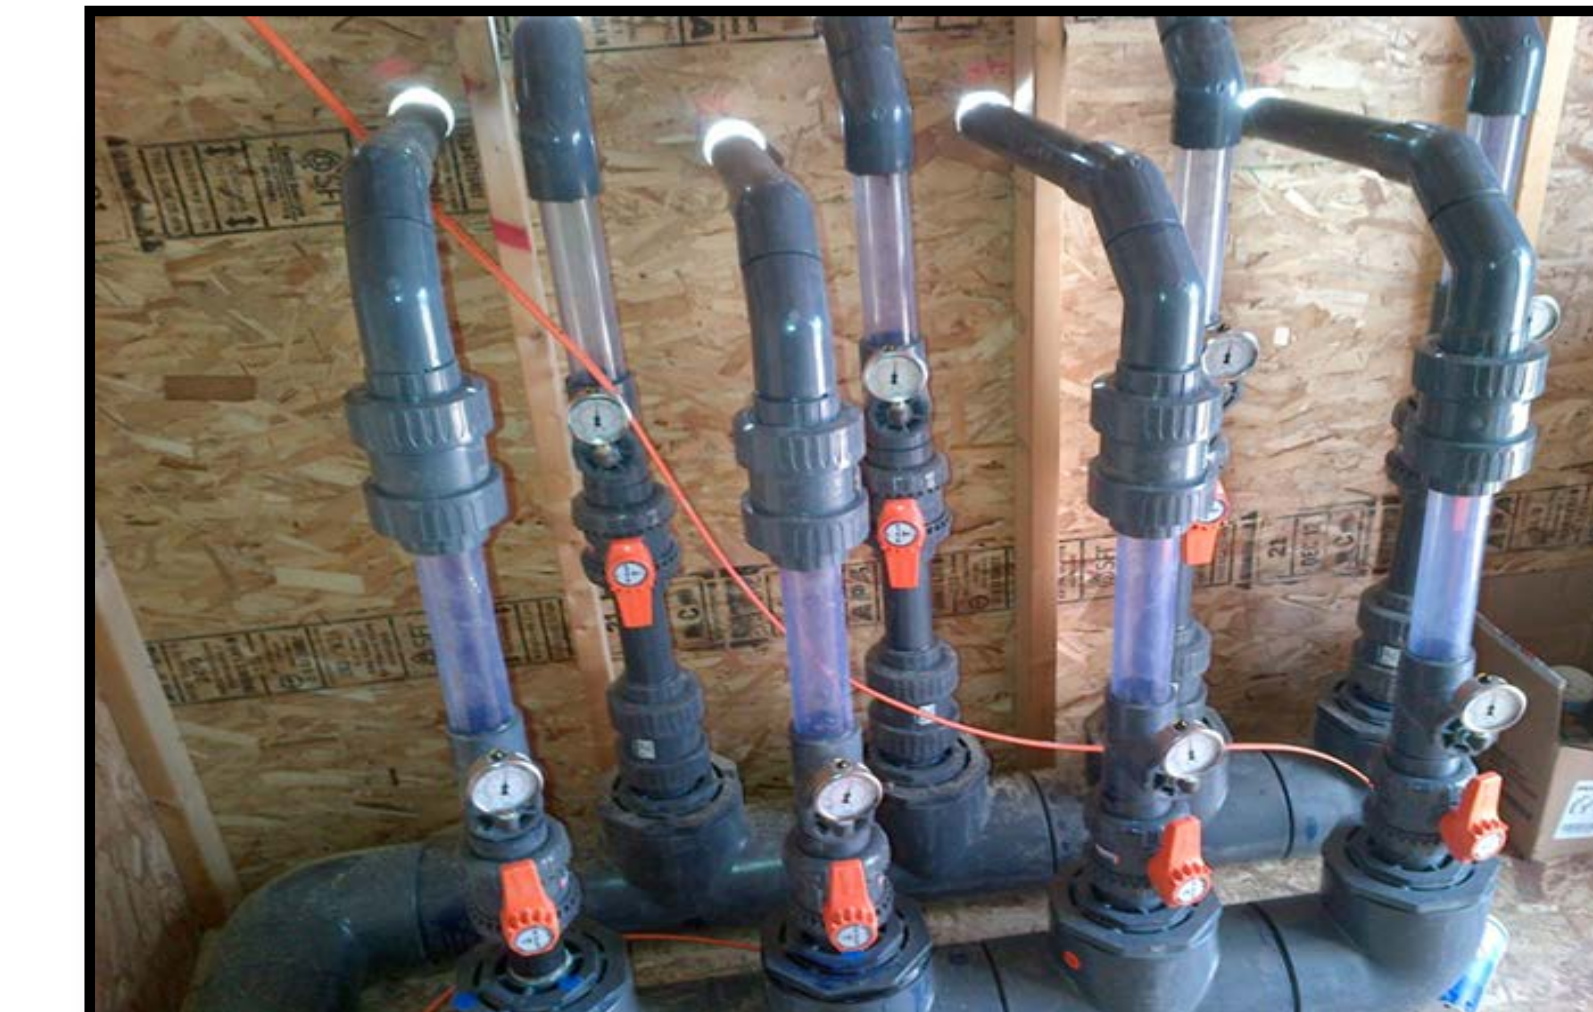
(Photo 10: View of the dewatering well header manifold. Note the clear PVC casing, which was used for visually assessing groundwater recovery and silt load.)

Included daily visual inspections (Figure 10) and a downhole camera evaluation:

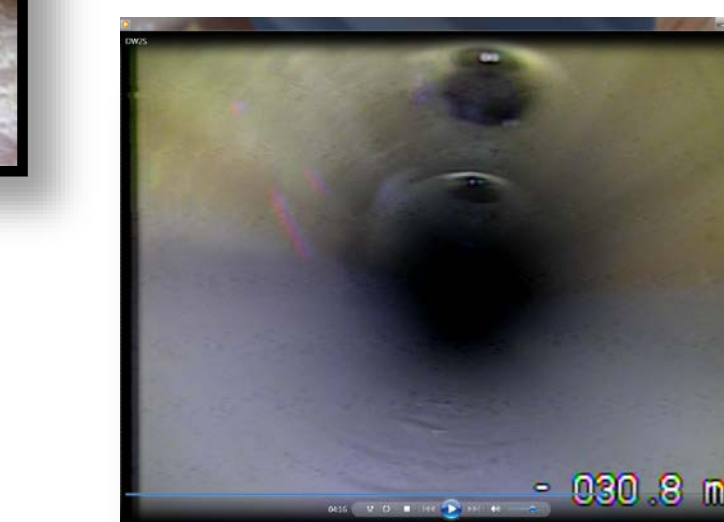
- Recovered groundwater in each well had a similar silt load during an initial 4 week operating period.
- Silt load decreased after approximately 4 weeks.
- A downhole camera was inserted into the geosynthetic and the standard PVC dewatering wells. Less silt was observed within the geosynthetic well compared with the standard PVC well (see Photo 11 and Photo 12).
- The PAWL lines within the nested well with inflatable packer and the carrier casing wells could not be removed; therefore, were inaccessible for the downhole camera assessment.

(Photo 11: Downhole camera assessment of the silt accumulation within the geosynthetic well. Note the air bubbles near the top of the well. The greyish colour along the bottom is likely water discoloration.)

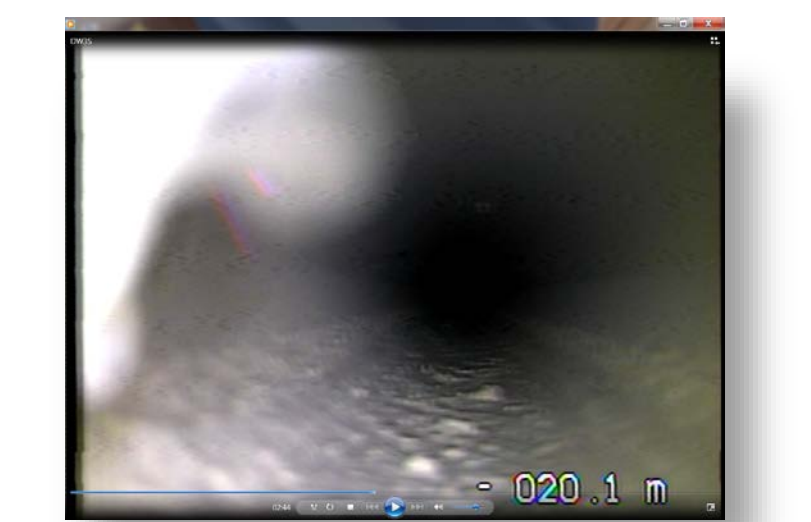
(Photo 12: Downhole camera assessment of the silt accumulation within a standard PVC well. Note the irregular silt accumulation at the bottom of the well and the suspended silt in the top left corner.)
